CT-387

Thomas C. McQueen House

5951 Huntingtown Road

Maryland Inventory of Historic Properties Form

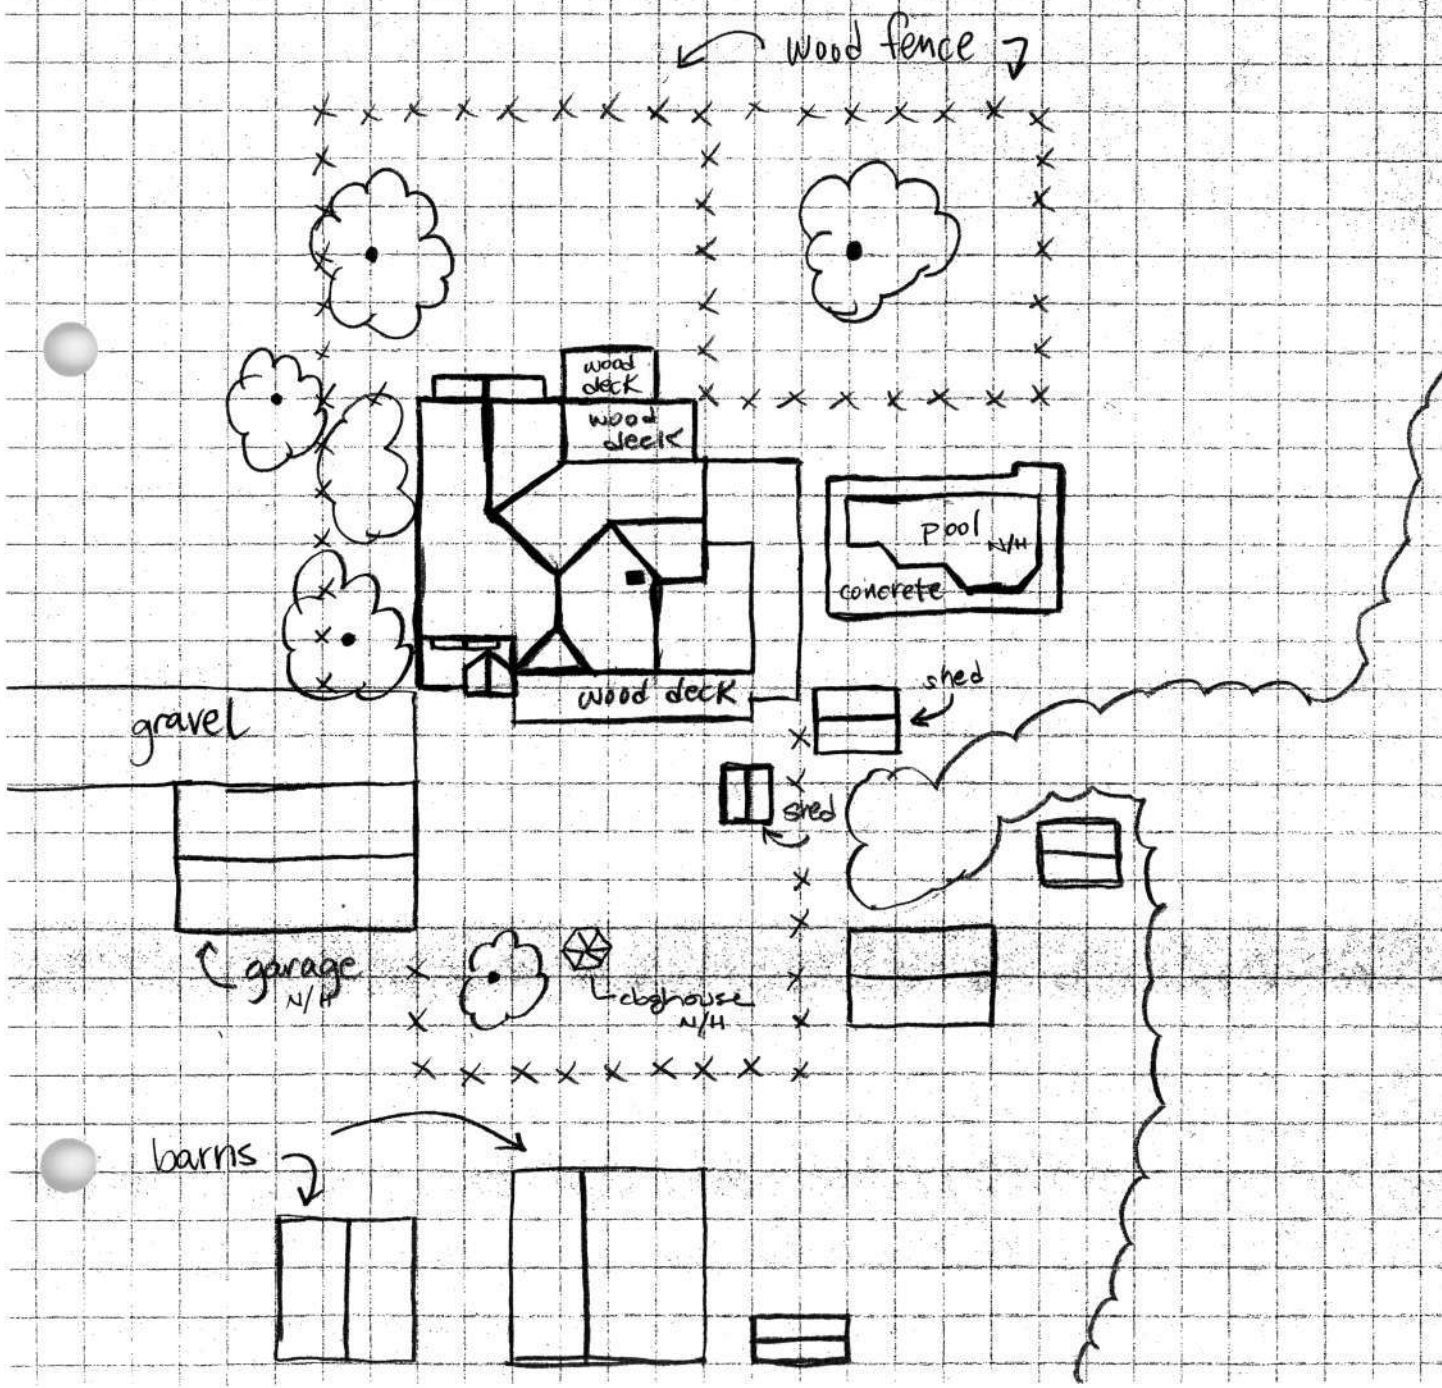
RESOURCE SKETCH

CT-387 THOMAS C. McQUEEN House
5951 Huntingtown Rd.

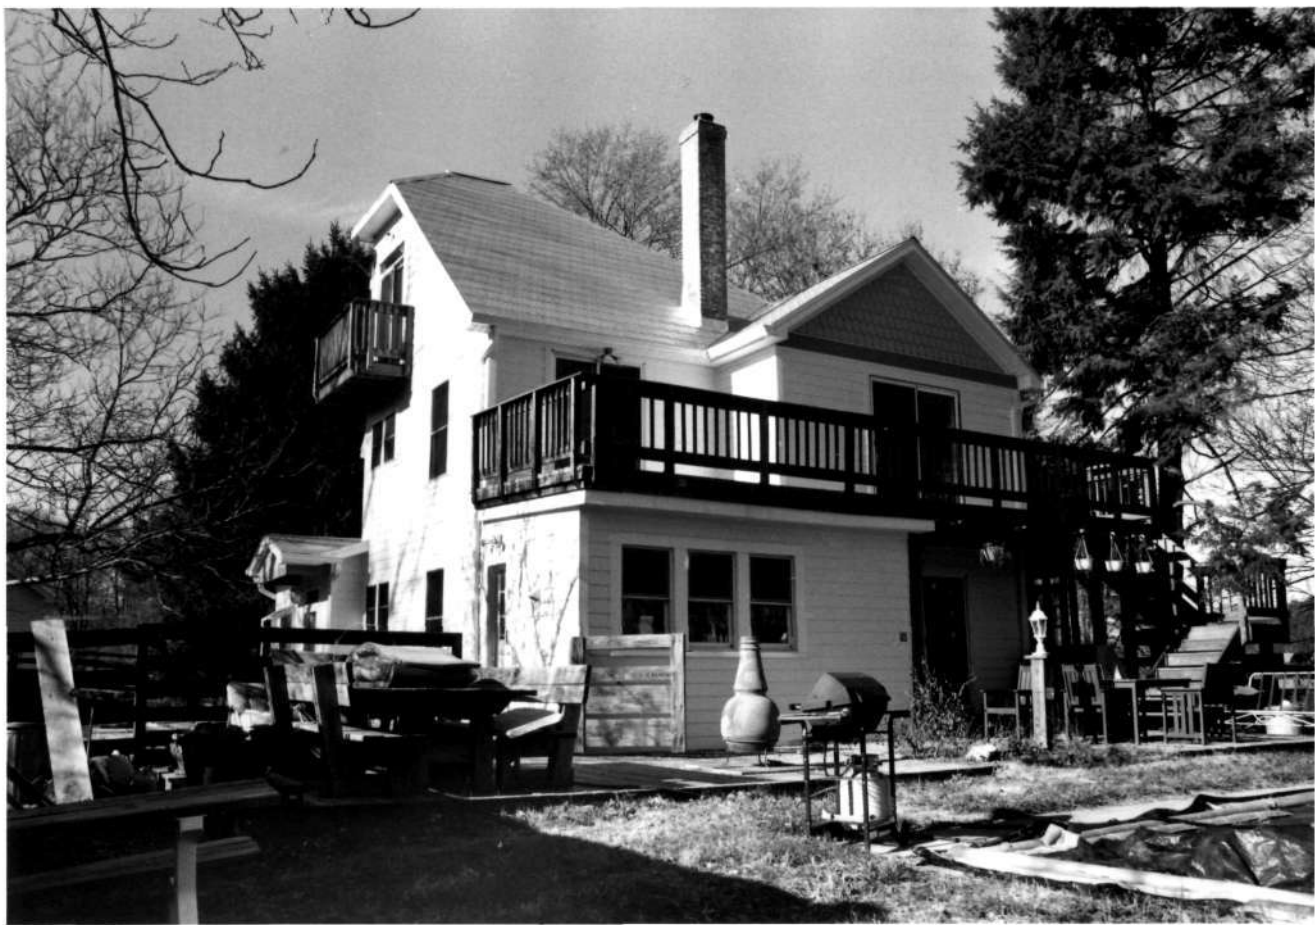
1 of 3

House, northeast elevation

PRIMARY RESOURCE. Constructed circa 1900, the wood-frame dwelling located at 5951 Huntingtown Road was substantially altered circa 2000. An undated photograph and previous MIHP form reveal that the dwelling originally featured a gable-front-and-wing form with a one-story shed porch on the recessed wing. Set on a solid, now obscured foundation, the dwelling features composite concrete siding and a half-hipped roof with a jerkinhead peak, projecting gables, and replacement pressed metal shingles. Overhanging eaves, a boxed aluminum cornice, and an interior-end chimney with corbeled cap further detail the structure. Standing two-and-a-half stories in height, the dwelling is marked by an irregularly fenestrated primary elevation. The two-and-a-half-story main block features a half gable with a jerkinhead peak, 1/1-vinyl windows, and a sliding-glass door with wood balcony on the half story. A one-story wing with a center gable houses the primary entry. Modern architectural detailing, recalling the Victorian-era Queen Anne style, was applied to the east and north elevations during the circa 2000 alterations. The east elevation features an off-center, projecting gable with fishscale shingles in the gable peak. This elevation has a partially enclosed, first-story porch and a second-story wood deck. Similarly, the north elevation features an off-center, projecting gable with a two-story, three-sided bay window projecting from it and detailed with a fanlight vent and 1/1 vinyl windows. An enclosed porch with roof balcony extends across the remaining portion of the elevation.

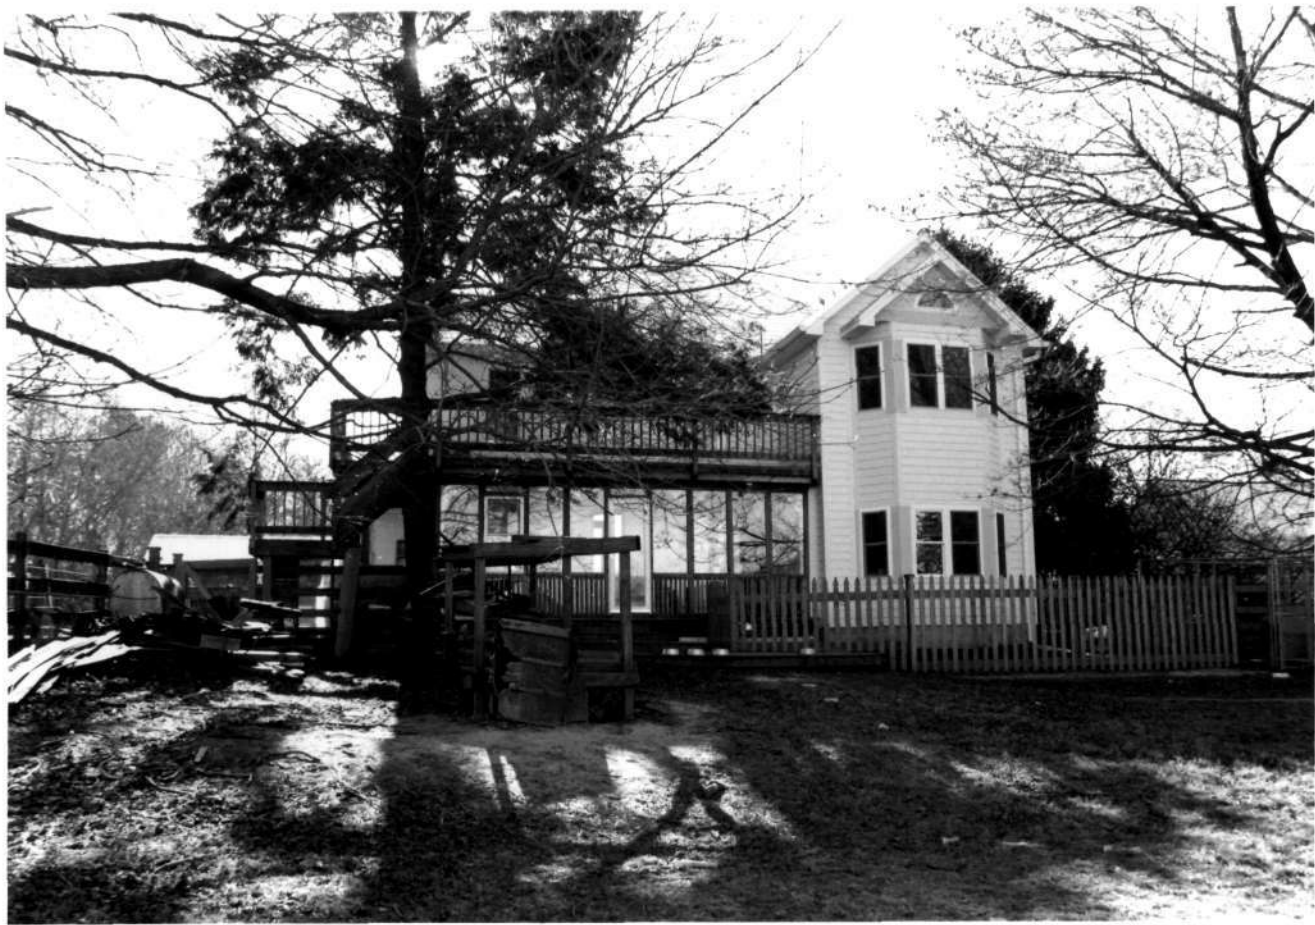
2 of 3

House, Southwest corner

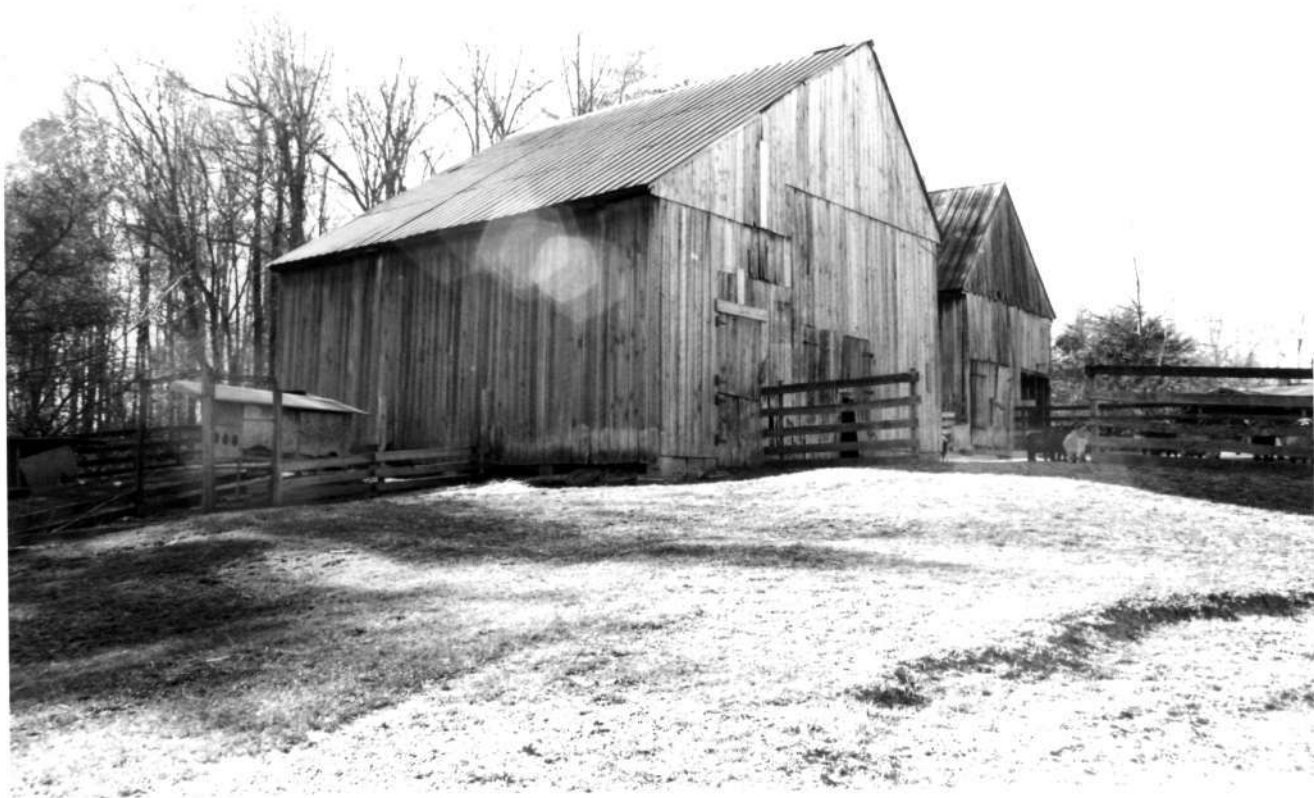
3083

Barns, view looking west

SECONDARY RESOURCES. Located southwest of the dwelling is a complex of agricultural buildings. A circa 1920 wood-frame tobacco barn features vertical-board cladding; a front-gabled, corrugated metal roof; and a concrete block pier foundation. Vertical-board doors access the one-and-a-half-story structure. Constructed circa 1920, a one-and-half-story tobacco barn features vertical-board cladding a front-gabled corrugated metal roof, and overhanging side elevation eaves. An open bay and a double-leaf, vertical board door access the structure. A one-story, wood-frame barn, constructed circa 1930, features a concrete block pier foundation, a side-gabled corrugated metal roof, and board-and-batten cladding. Standing one story in height, a wood-frame shed, constructed circa 1930, features vertical-board cladding, partially covered in metal sheeting. The shed features a front-gabled roof with corrugated metal cladding. A four-light, wood window lights the structure. A wood-frame chicken house, constructed circa 1980, features a metal-clad gable roof and vertical board cladding.

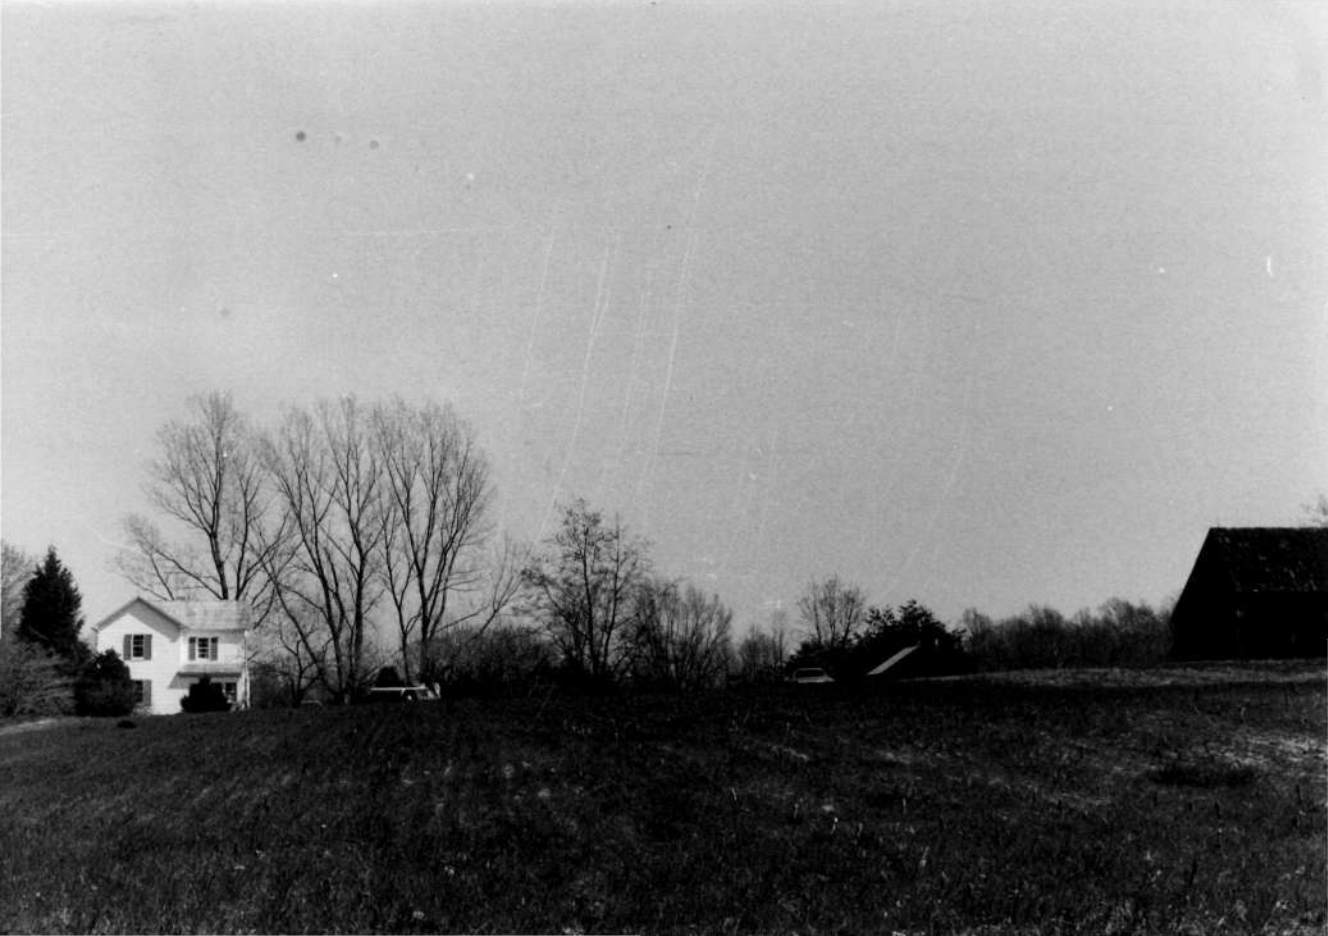
CT-387

W elevation

This two-story frame house is built in an L-shape, with one section projecting at the front. Each elevation of each section consists of a single bay. A one-story porch fills in the "L" at the facade. A kitchen addition completes the plan. All sections are covered with gable roofs.

Windows have six over six pane sashes with pairs of two paneled shutters.
